# Biological evaluation of anti-fouling paints

by R. BALASUBRAMANYAN,

*Central Institute of Fisheries Technology, (Craft & Gear Wing), Cochin.*

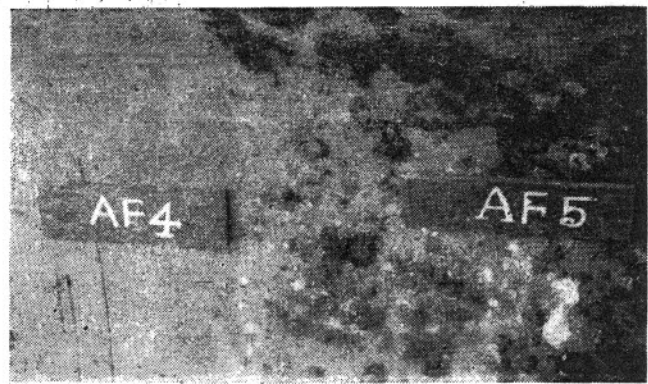
Position	Eye estimation	Barnacles	Oysters	Tube-worms	Hydroids	Bryozoans	Algae	
Port side bow AF4	Very light 3%	2% on the water-line zone	—	—	—	—	1%*	Fig. 2
Port side quarter AF5	Very heavy 85%	10%	65%	2%	2%	4%	2%*	Fig. 2
Starboard bow AF5	Very heavy 80%	8%	60%	3%	2%	5%	1%*	Fig. 3
Starboard quarter AF4	Very light 4%	1% scattered	—	—	2%	—	1%*	Fig. 3
Controls	Very heavy 80%	10%	60%	4%	2%	3%	1%*	
Portside rudder upper half AF4	Very light 3%	2%	1%	—	—	—	—	Fig. 4
Lower half AF5	Very heavy 80%	78%	1%	—	—	—	—	Fig. 4
Starboard rudder upper half AF5	Very heavy 75%	72%	1%	—	—	2%	—	Fig. 5
Lower half AF4	Very light 4%	4%	—	—	—	—	—	Fig. 5

Fig. 2  
Condition of fouling on the starboard side of the boat.

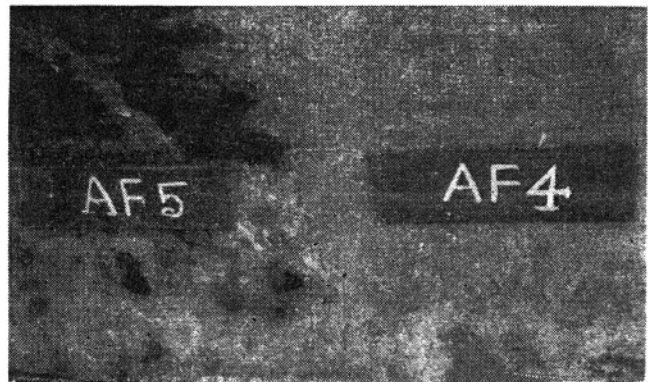
Fig. 3  
Condition of fouling on the port side of the boat.  
Condition of fouling on the rudder

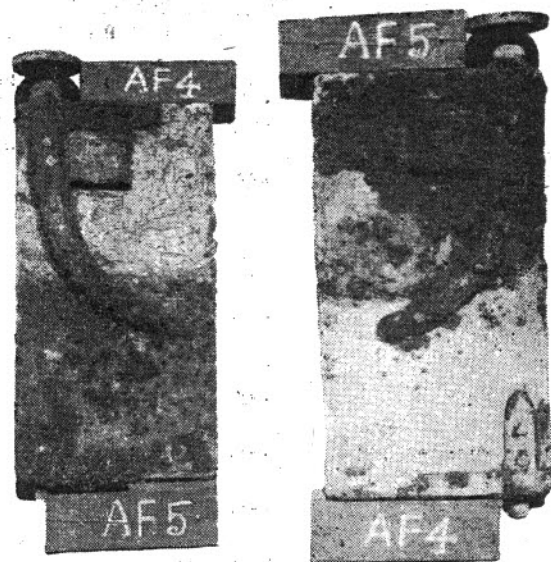
port side.  
Fig. 4

star board side.  
Fig. 5

Note: AF4 has been free from fouling consistently.
