# CATHODIC PROTECTION OF THE HULLS OF FISHING TRAWLERS IN INDIA\*

K. RAVINDRAN & R. BALASUBRAMANYAN  
*Central Institute of Fisheries Technology, Cochin-682011*

\* Paper presented at the Symposium on Cathodic Protection held at Kanpur (India) during Dec. 12-14, 1973.

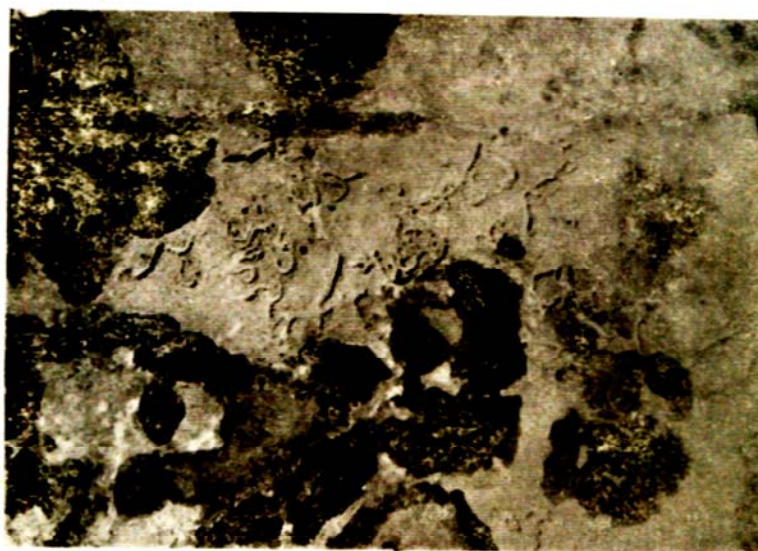
limit making copper virtually non-toxic and hence fouling occurs. Fig. II shows such a phenomenon of inactivation of copper where the copper sheathing has been fouled by tube worms as well as oysters (only impressions seen).

Fig. II. Marine fouling on over-protected copper sheathing.

inherent antifouling properties of the metal. It is an accepted criterion that in order to impart antifouling properties a dissolution rate of  $10\mu$  gm copper/ $\text{Cm}^2$ /day is necessary. Over protection leads to a slower dissolution rate below this critical
