# Biological evaluation of anti-fouling paints

by R. BALASUBRAMANYAN,

*Central Institute of Fisheries Technology, (Craft & Gear Wing), Cochin.*

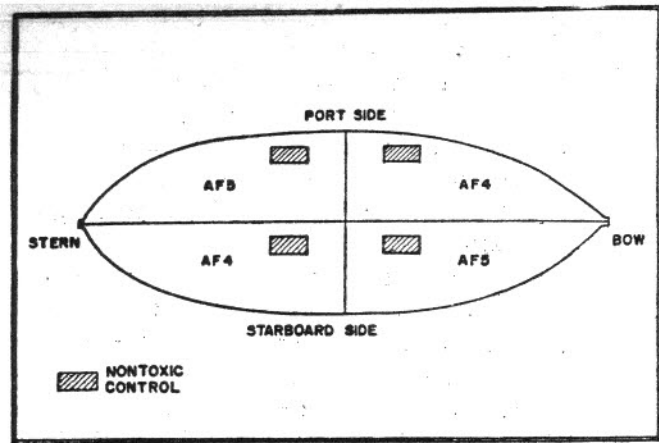
Position	Eye estimation	Barnacles	Oysters	Tube-worms	Hydroids	Bryozoans	Algae	
Port side bow AF4	Very light 3%	2% on the water-line zone	—	—	—	—	1%*	Fig. 2
Port side quarter AF5	Very heavy 85%	10%	65%	2%	2%	4%	2%*	Fig. 2
Starboard bow AF5	Very heavy 80%	8%	60%	3%	2%	5%	1%*	Fig. 3
Starboard quarter AF4	Very light 4%	1% scattered	—	—	2%	—	1%*	Fig. 3
Controls	Very heavy 80%	10%	60%	4%	2%	3%	1%*	
Portside rudder upper half AF4	Very light 3%	2%	1%	—	—	—	—	Fig. 4
Lower half AF5	Very heavy 80%	78%	1%	—	—	—	—	Fig. 4
Starboard rudder upper half AF5	Very heavy 75%	72%	1%	—	—	2%	—	Fig. 5
Lower half AF4	Very light 4%	4%	—	—	—	—	—	Fig. 5

Apart from raft exposure the commercial preparations of AF4 and AF5 were under service test from October to March when severe fouling conditions persisted. It is seen from Table II and the enclosed photographs — Figures 2 to 5 — that areas painted on the hull with AF5 have been severely fouled by all the organisms that were found on the test panels treated with the same composition and AF4 was comparatively free from any of the major fouling forms throughout except in few spots where the paint film was damaged due to mechanical causes. Wherever AF4 and AF5 were used on the rudder the amount of fouling was also similar to that noted on the hull but instead of oysters more of barnacles were noted. Thus it is seen that the performance of AF4 and AF5 was mostly of the same magnitude both under raft exposure and service tests. The fouling forms that were able to settle freely on AF5 could not do so on AF4 under identical conditions. The present observations only confirm the fact that AF4 has been adequately toxic and preventing all the fouling forms normally settling on the non-toxic controls as well as on the other treated panels for a prolonged period. It is quite evident now that from the present lot of commercial antifouling paints tested only AF4 would have given adequate protection on boats when others would not have served any purpose at all and hulls treated with such inferior paints would have been heavily fouled by the time their dry-docking is due. Since ship bottom paints are specific in their function, their performances should not be left to mere chance.
